| | Report No.<br>2016-20 | Tender:<br>2016-189 | Publishing date:<br>27.4.2016 | Number of<br>pages:<br>20 |
| | Customer:<br>Kingi Ltd. | | Representative of customer:<br>Jorma Kinnunen | |
| <h2>PROHESION TEST OF METAL ROOFING SCREWS</h2> | | | | |

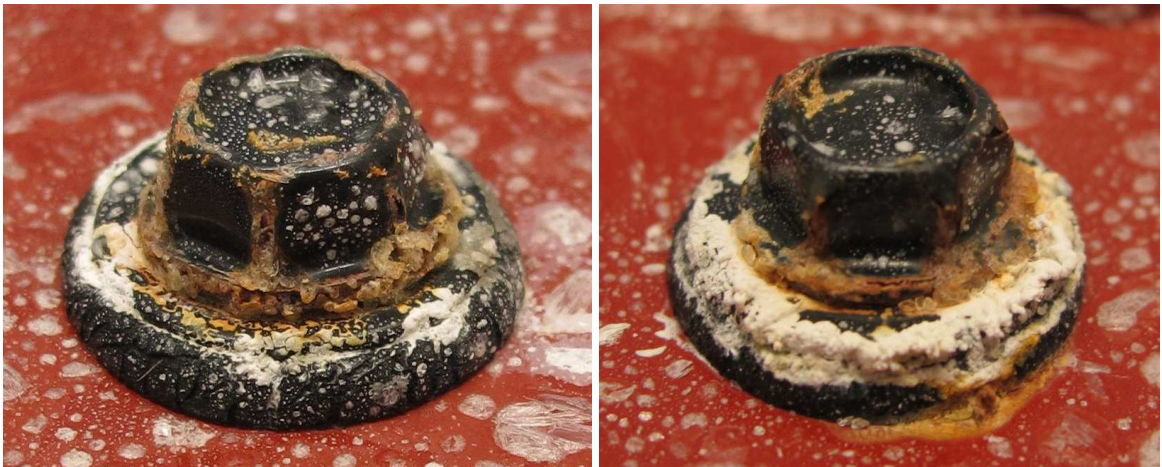
The worst screws were rusty in the first intermediate inspection after 187 hours, but the test was continued in order to follow the further corrosion. In the next inspection after 425 hours most of the screws made by the other manufacturers were totally deteriorated (figure 4). After 618 hours the test rack with other manufacturers' screws was removed from test because they had reached the point after which they could not have been maintained for further use (EN 12944-1).

**Figure 4.** Screws A (Würth) ja E (Berner) after 425 hours test time.

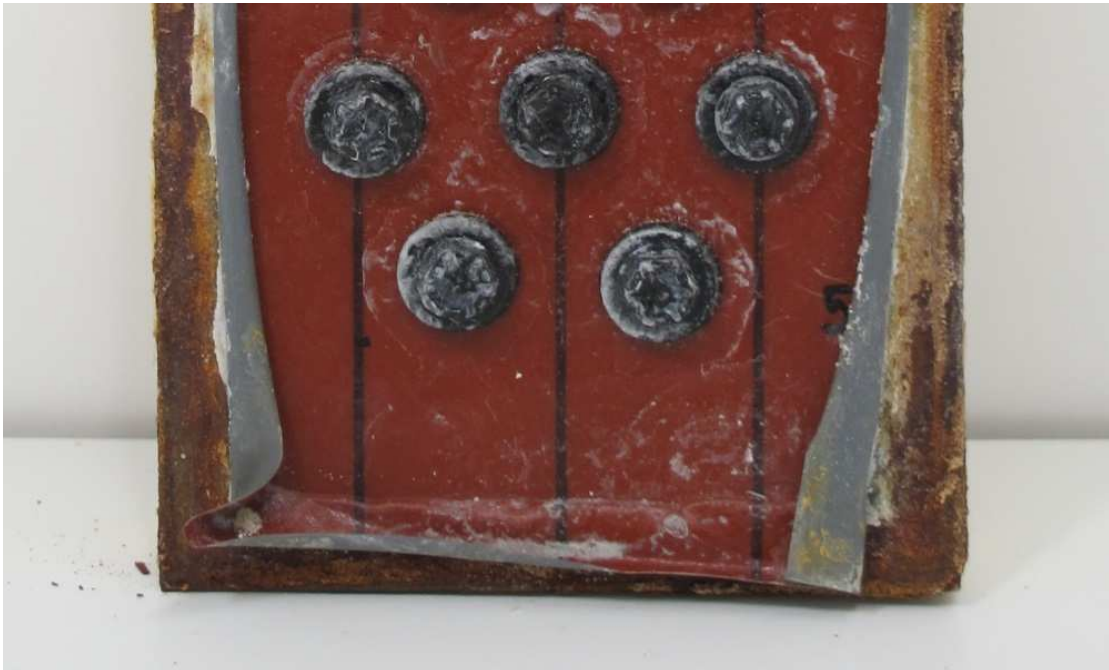
When comparing corrosion resistance of Kingi screws and the Pural coating (which was used on the sample racks) both the screws and the painted sheet were in a good condition. Corrosion and delamination of coating was found only on the cutting edges (figures 5 and 6). 1000 hour prohesion test is a harsh test method and it accelerates corrosion phenomenon. It is unusual that the products in reality end up to such a harsh conditions.

**Figure 5.** Kingi screws and Pural thin sheet metal after 1000 hours test.

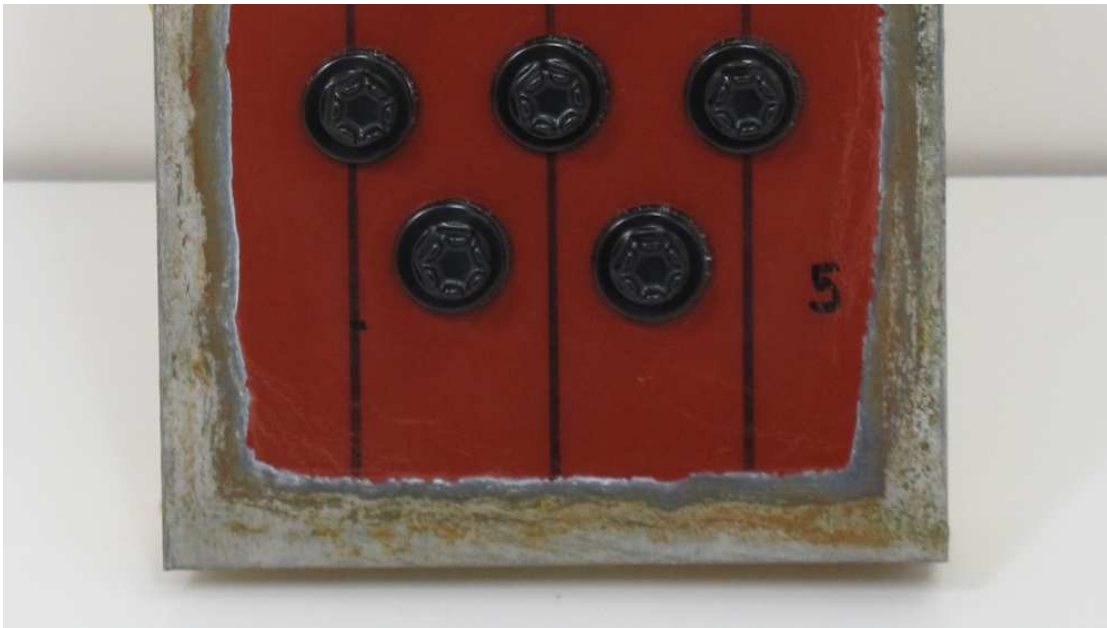
**Figure 6.** Kingi screws and Pural thin sheet after test. Delaminated paint is removed.

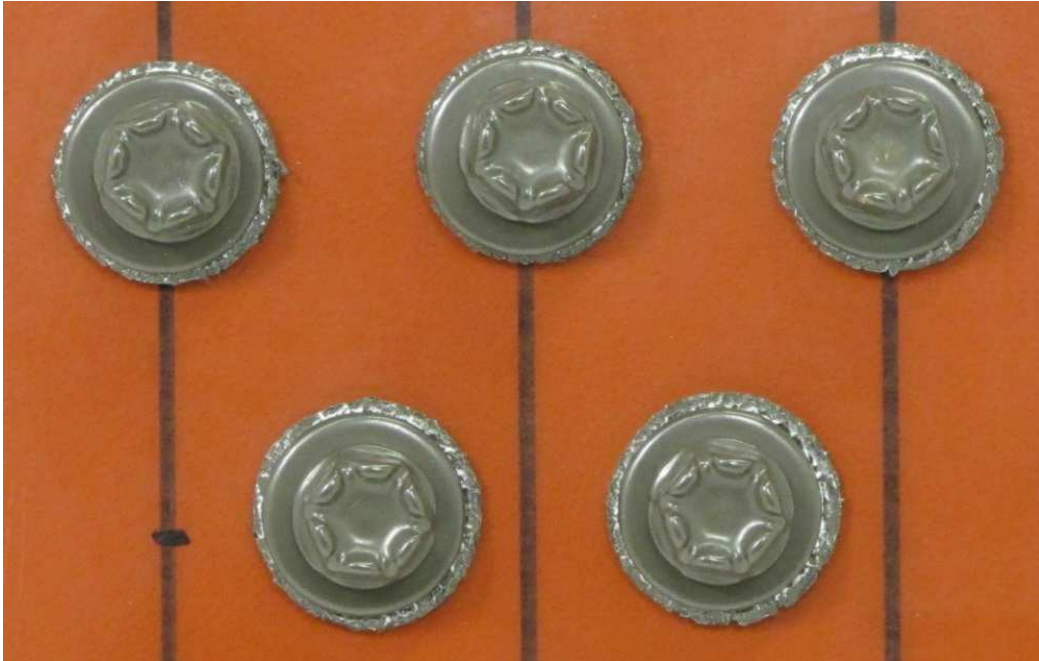
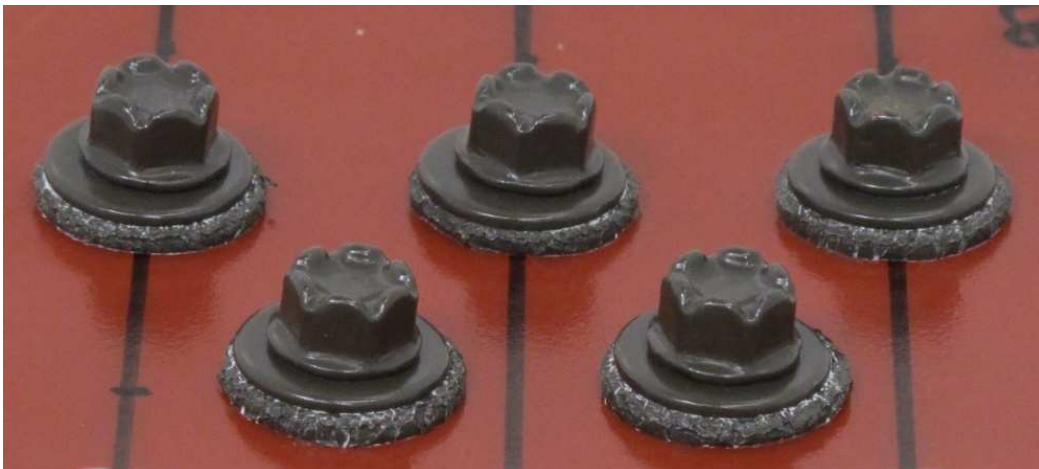
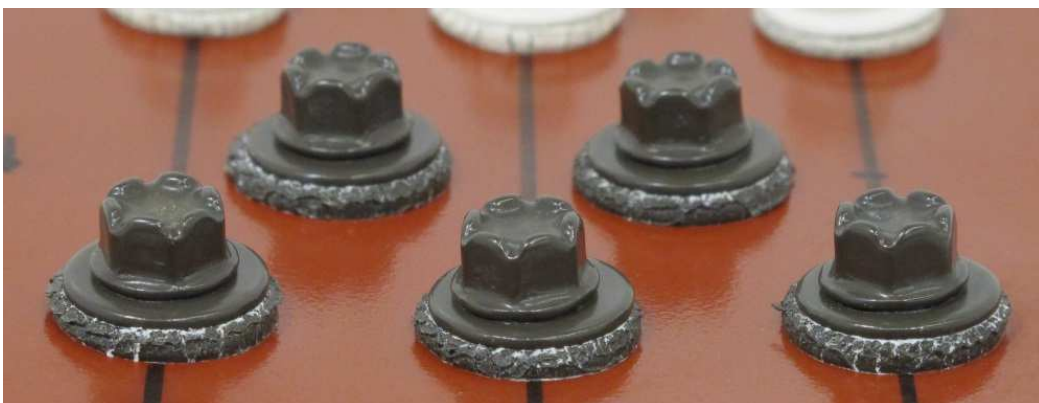
#### 4.1 Sample 1, Kingi RR32 dark brown

One of the five screws had small amount of red rust at the end of the test. No paint was delaminated after removal of delaminated paint.

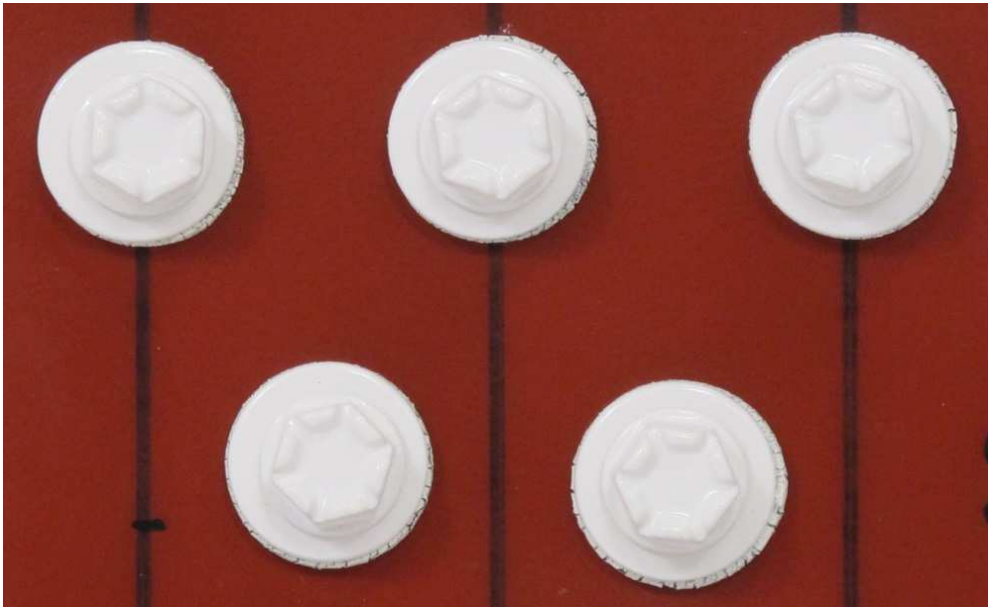
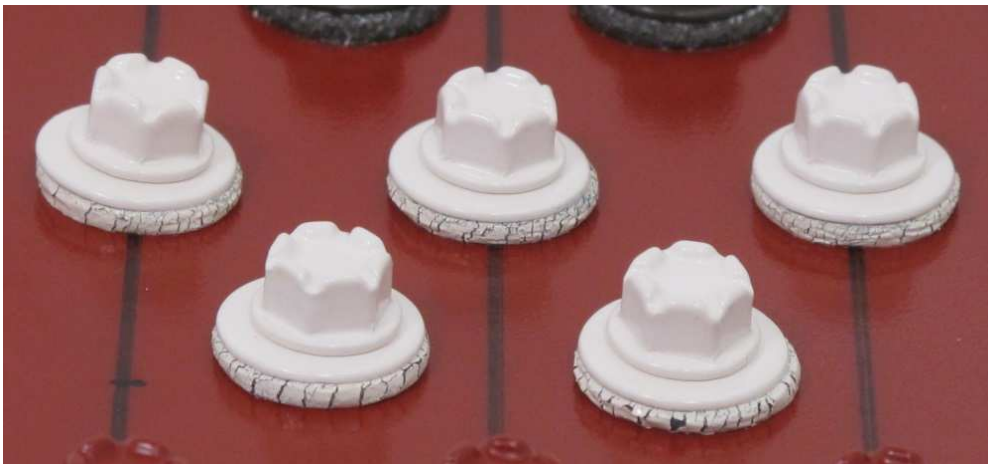
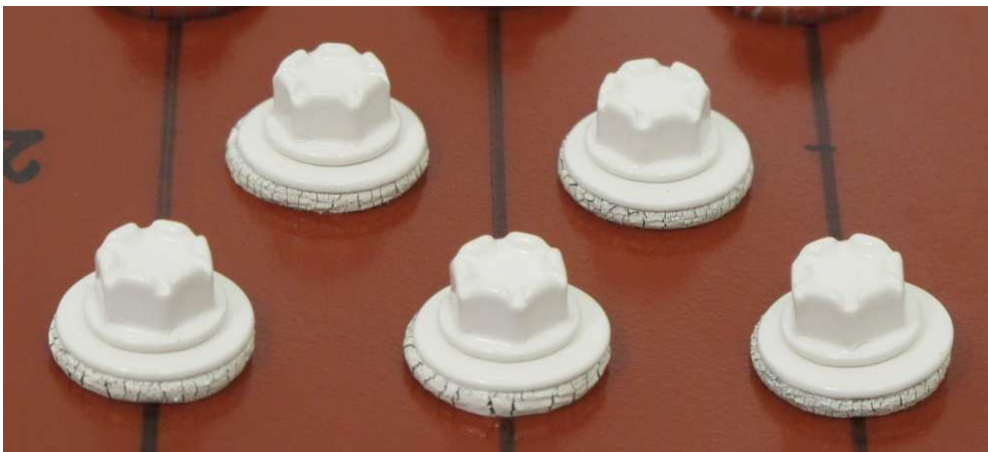
#### 4.2 Sample 2, Kingi RR20 white

The screws survived 1000 hour test without any defects. No paint was delaminated.

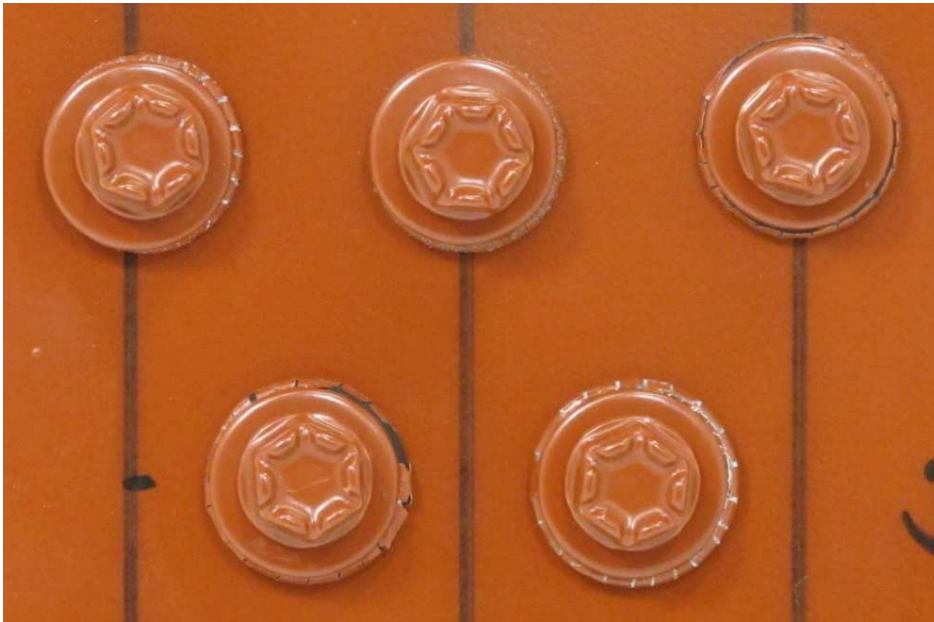
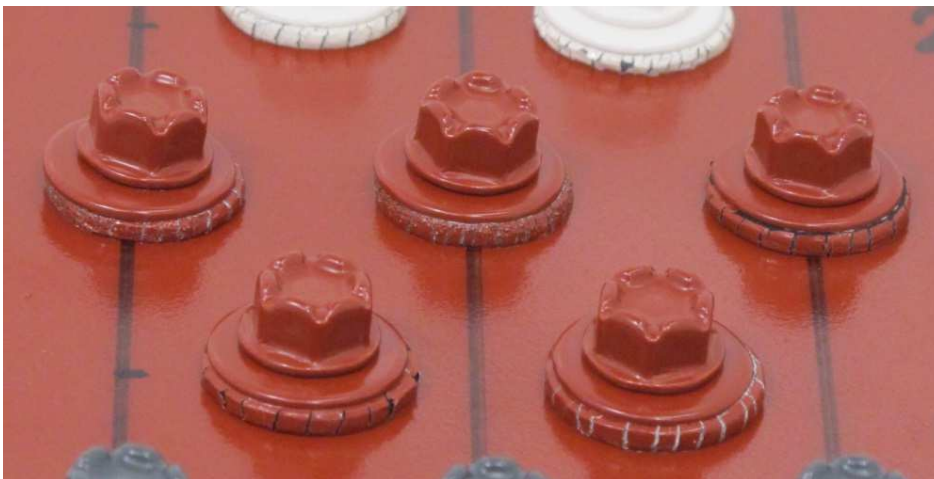
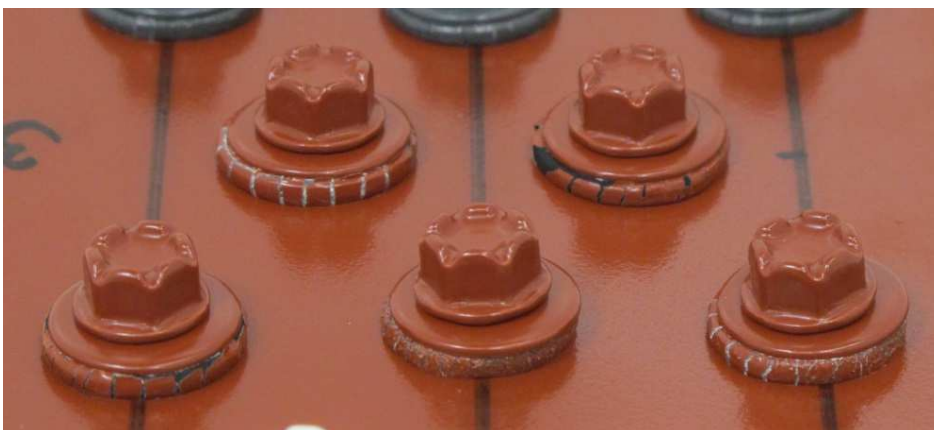
#### 4.3 Sample 3, Kingi RR29 red

The screws survived 1000 hour test without any defects. No paint was delaminated.

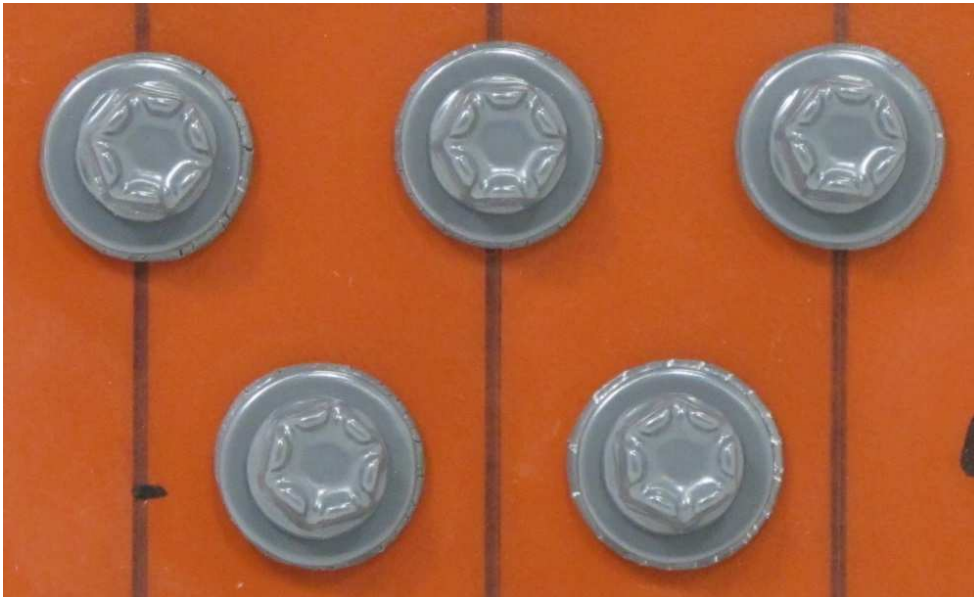
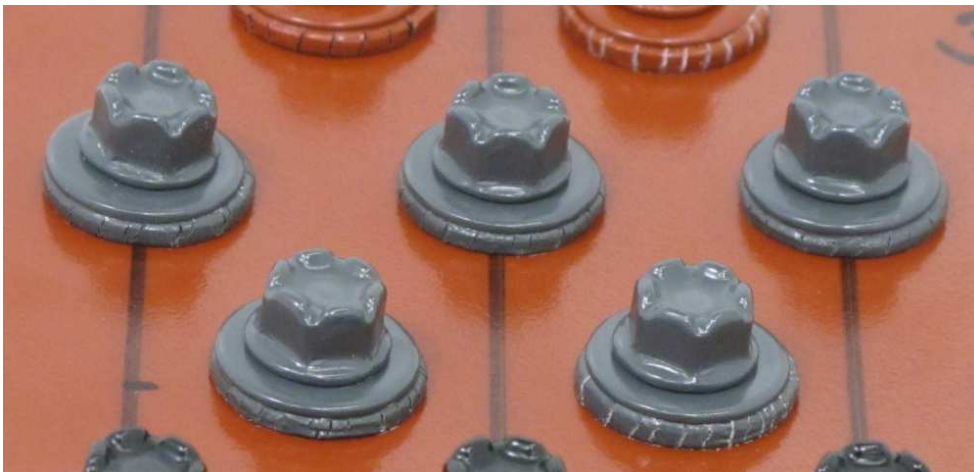
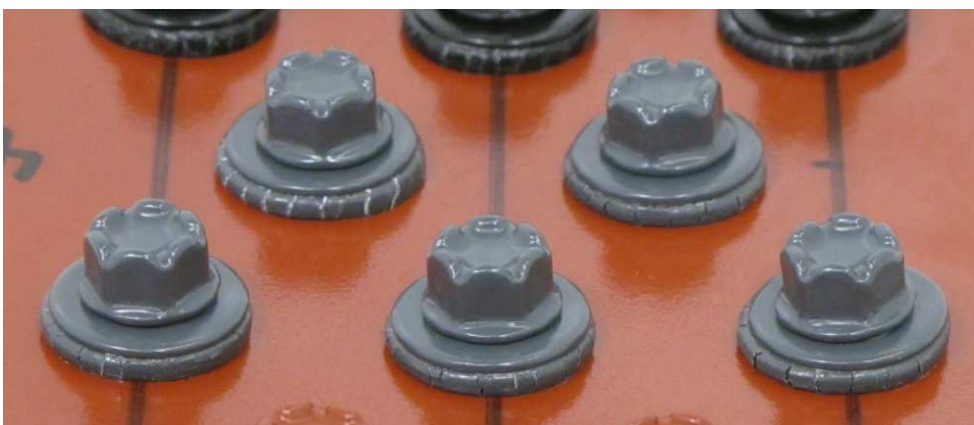
#### 4.4 Sample 4, Kingi RR23 dark grey

The screws survived 1000 hour test without any defects. No paint was delaminated.

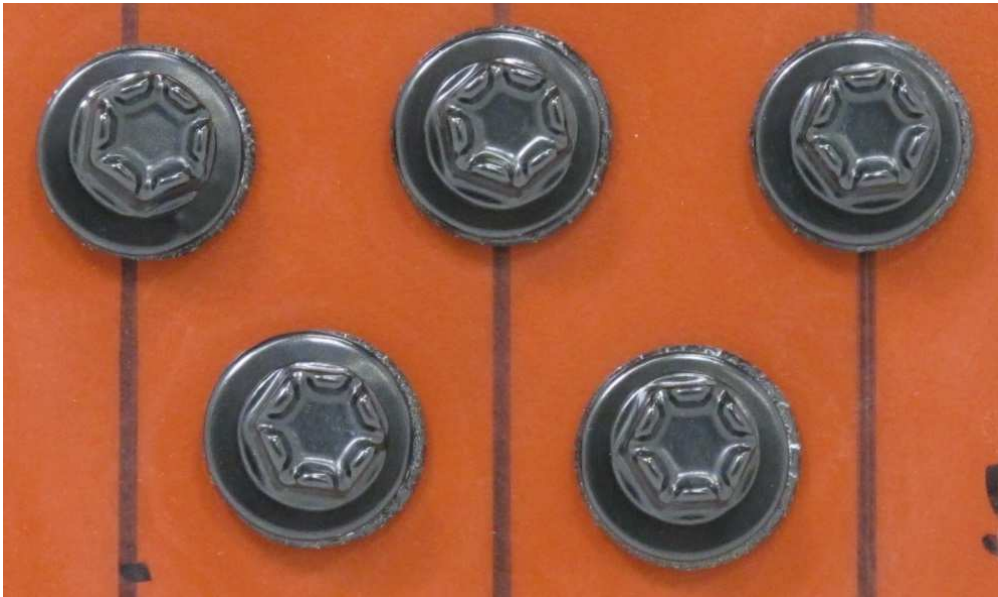
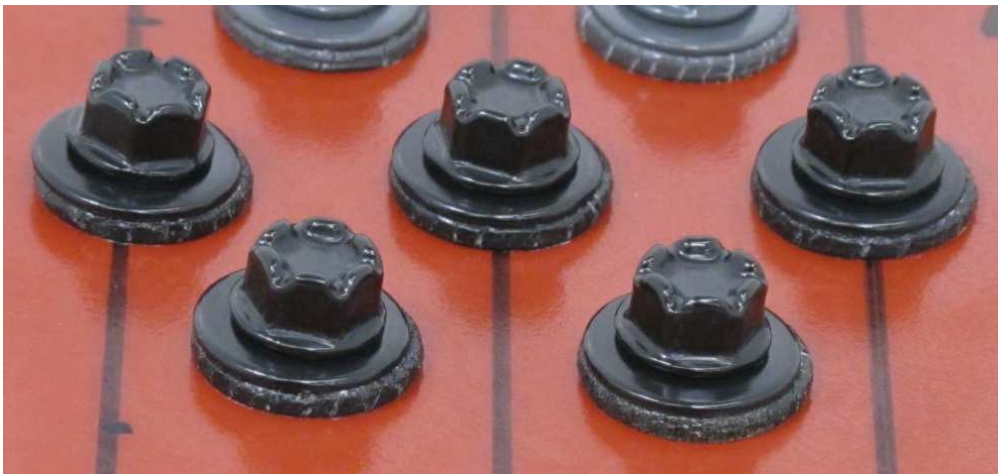
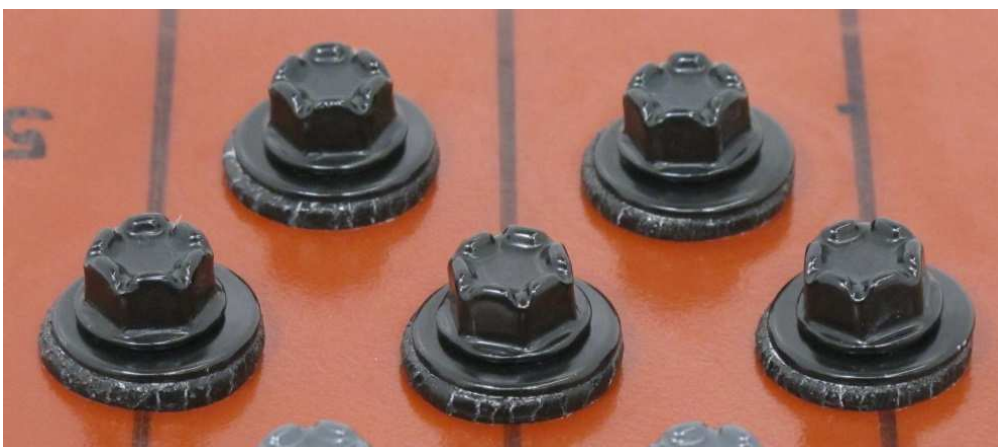
#### 4.5 Sample 5, Kingi RR33 black

The screws survived 1000 hour test without any defects. No paint was delaminated.

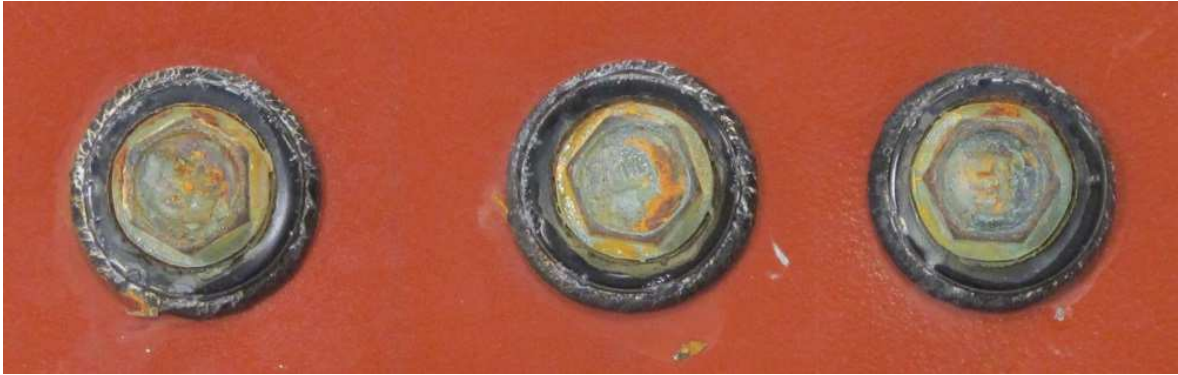
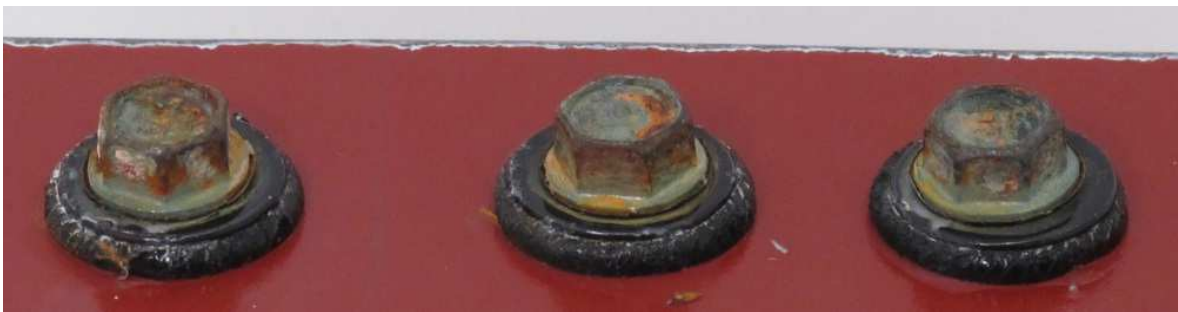
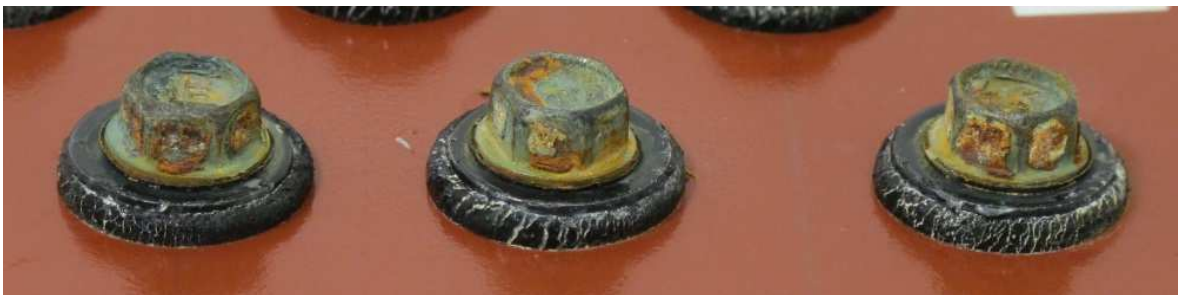
#### 4.6 Sample A, Würth 1

Some incipient rusting of screws was found already in the first intermediate inspection after 187 hours of testing. In the second inspection after 425 hours, there was plenty of rust and after 572 hours the screws were in a really bad condition and they had a lot of red rust. Test was ended after 618 hours. When the delaminated paint was removed, all the paint was lost.

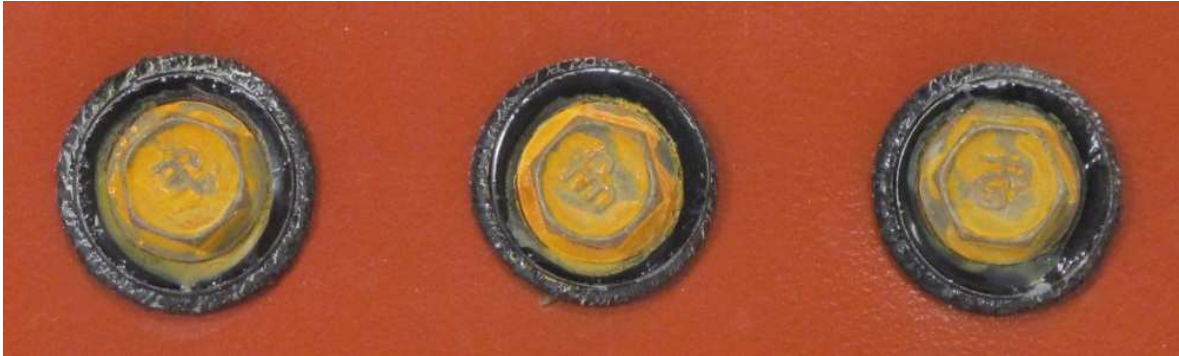
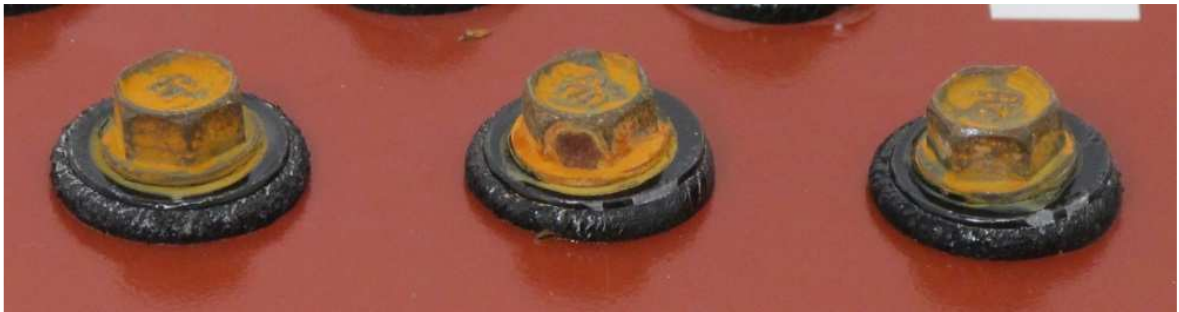
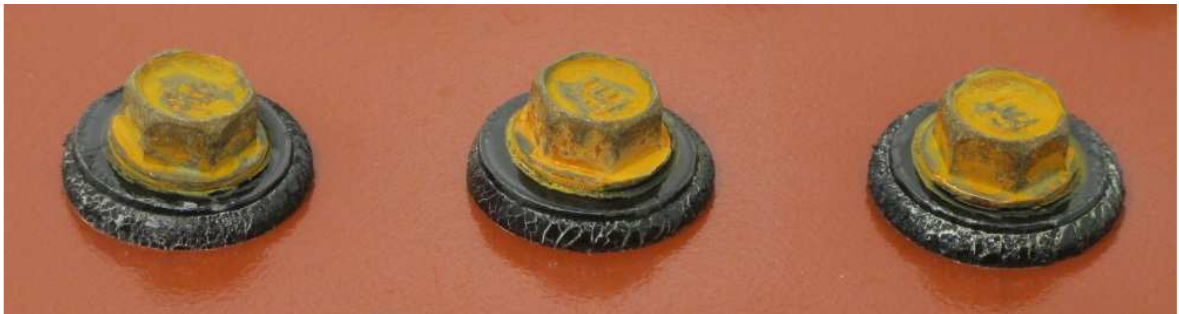
#### 4.7 Sample B, PROF

Some incipient rusting of screws was found already in the first intermediate inspection after 187 hours of testing. In the second inspection after 425 hours, there was plenty of rust and after 572 hours the screws were in a really bad condition and they had lots of red rust. Test was ended after 618 hours. When the delaminated paint was removed, all the paint was lost.

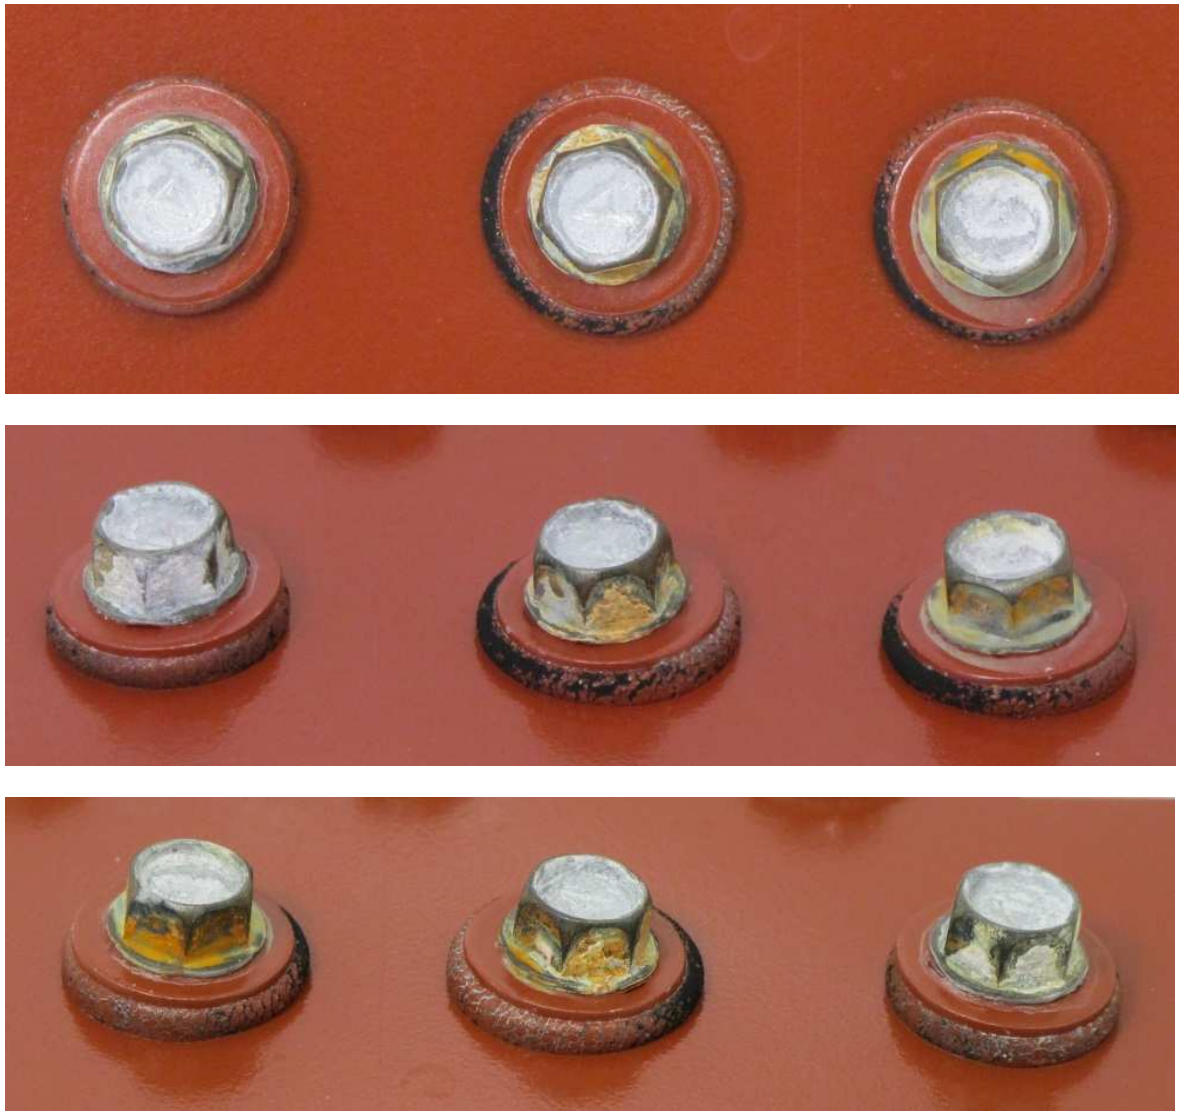
#### 4.8 Sample C, Ruukki (manufacturer Red Horse)

Some paint came loose already during mounting before the test. There was a bit of incipient rusting during the first inspection after 187 hours. In the second inspection after 425 hours, there was a small amount of rust and after 572 hours the screws were in a bad condition with lots of red rust. Test was ended after 618 hours. When the delaminated paint was removed, all the paint was lost.

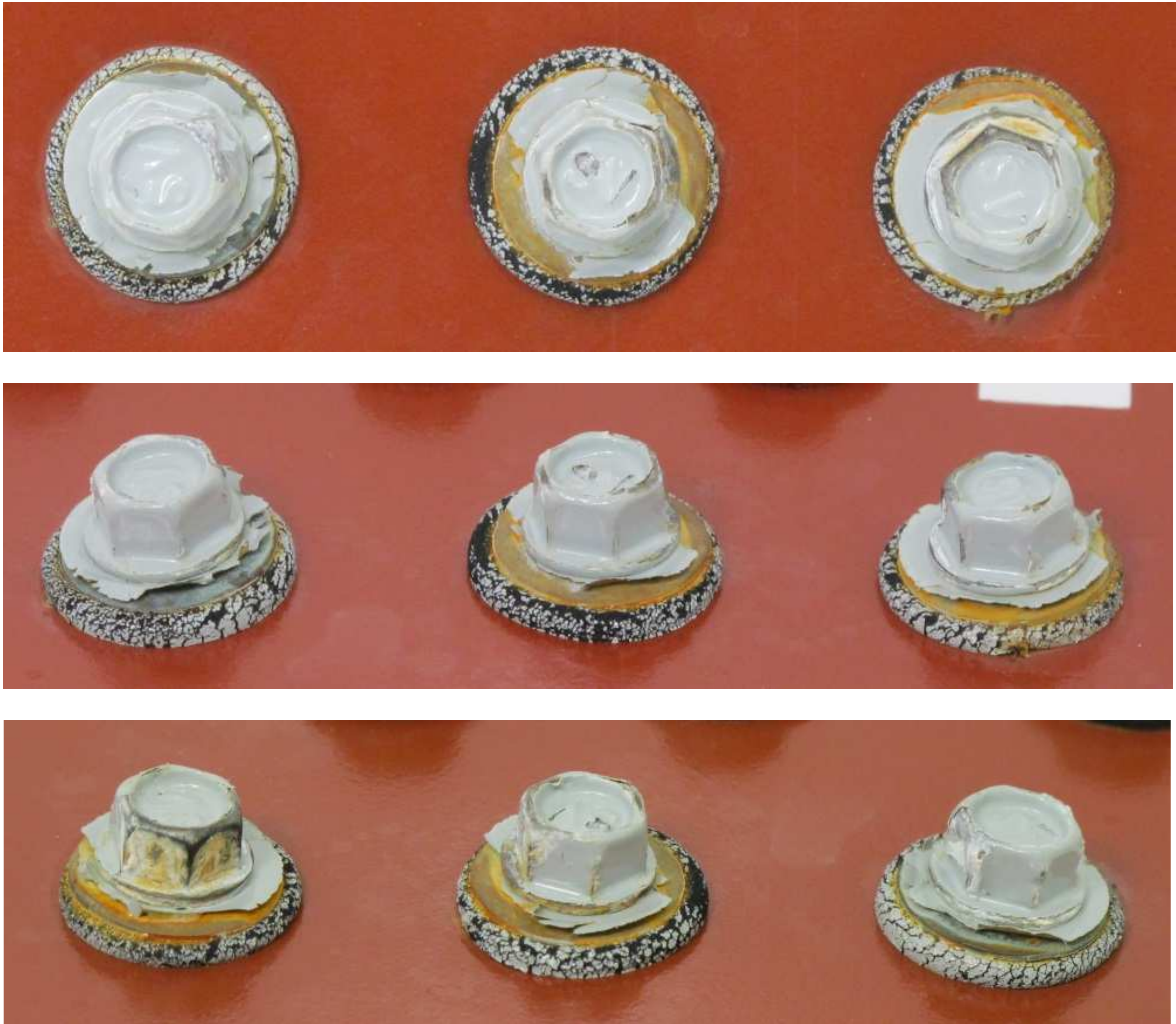
#### 4.9 Sample D, Essve

Some of the paint lost adhesion already during mounting before the test. There was small amount of incipient rusting during the first inspection after 187 hours. In the second inspection after 425 hours, there was a small amount of rust and after 572 hours the screws were in a bad condition with lots of red rust. Test was ended after 618 hours. When the delaminated paint was removed, the paint was partly lost.

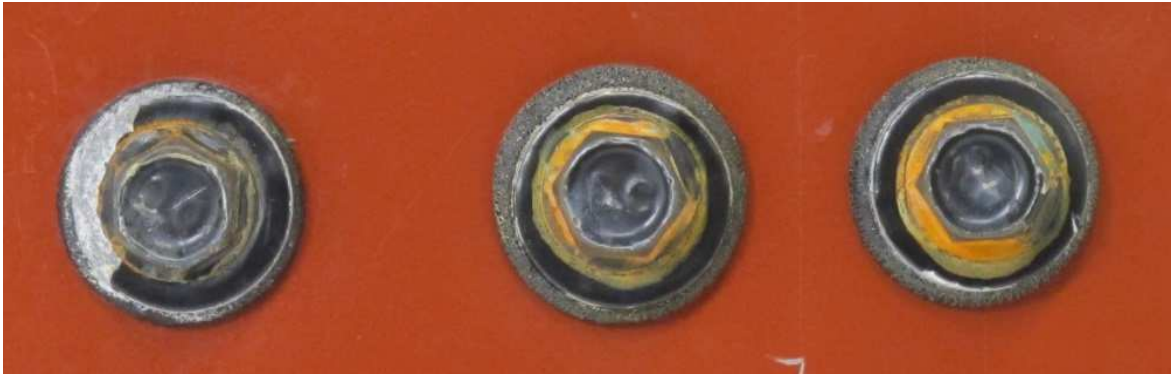
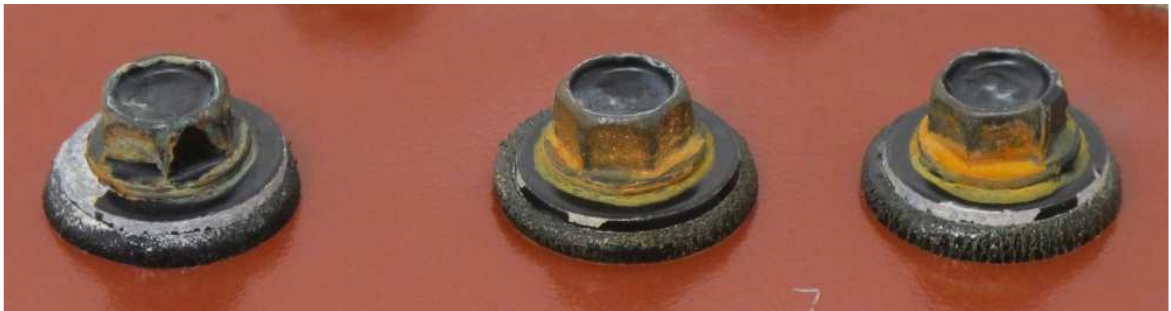
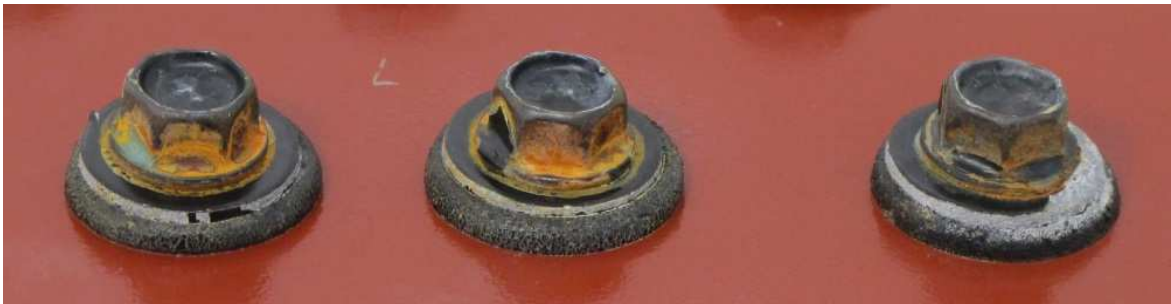
#### 4.10 Sample E, Berner

Some of the paint lost adhesion already during mounting before the test. There was small amount of incipient rusting during the first inspection after 187 hours. In the second inspection after 425 hours, there was a small amount of rust and after 572 hours the screws were in a bad condition with lots of red rust. Test was ended after 618 hours. When the delaminated paint was removed, almost all the paint around the screw head was lost. The paint on the head remained intact.

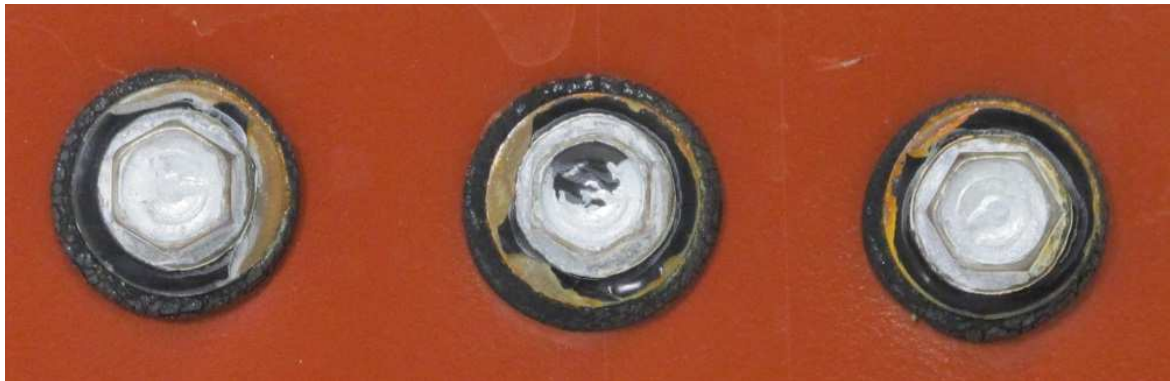
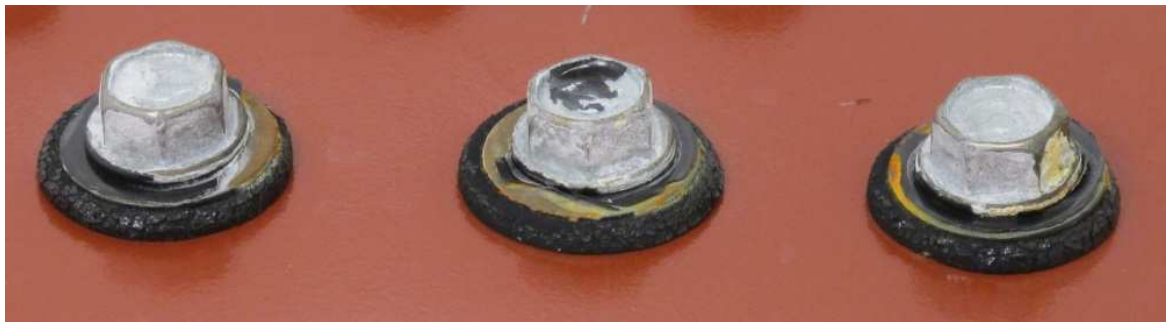
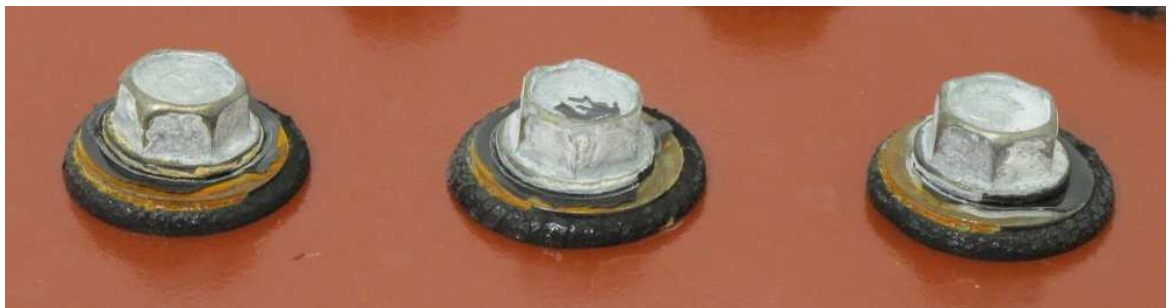
#### 4.11 Sample F, IKH

The screws were in a good condition during the first inspection after 187 hours. There was small amount of rust after 425 hours and 572 hours. The test was ended after 618 hours. When the de-laminated paint was removed, almost all the paint was lost.

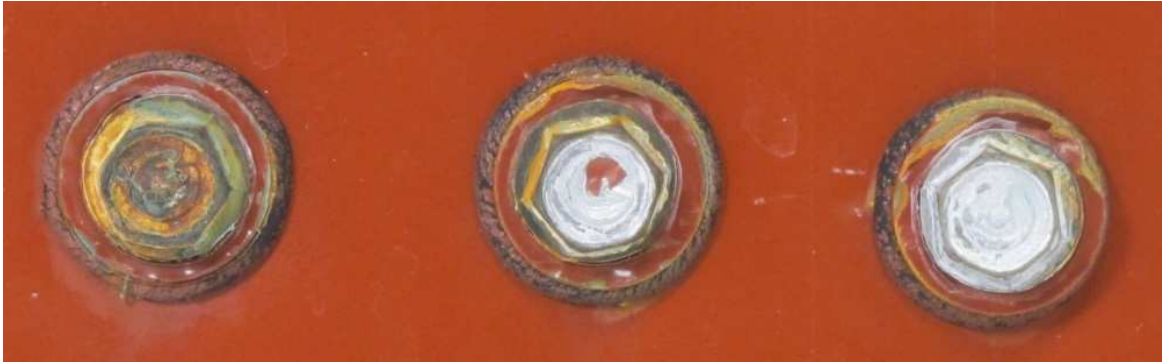
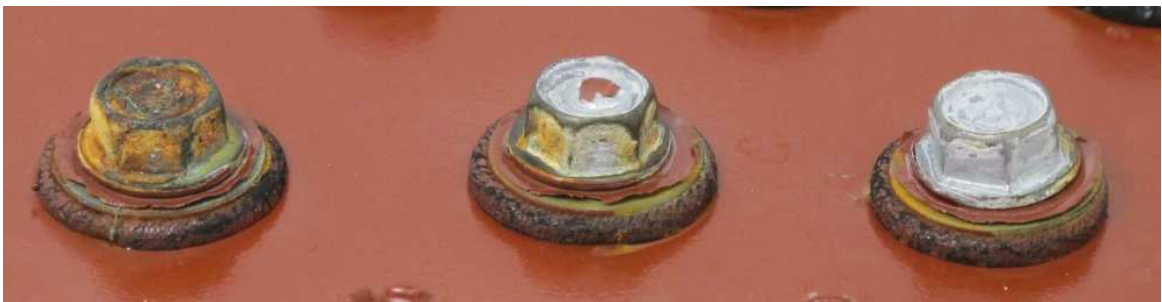
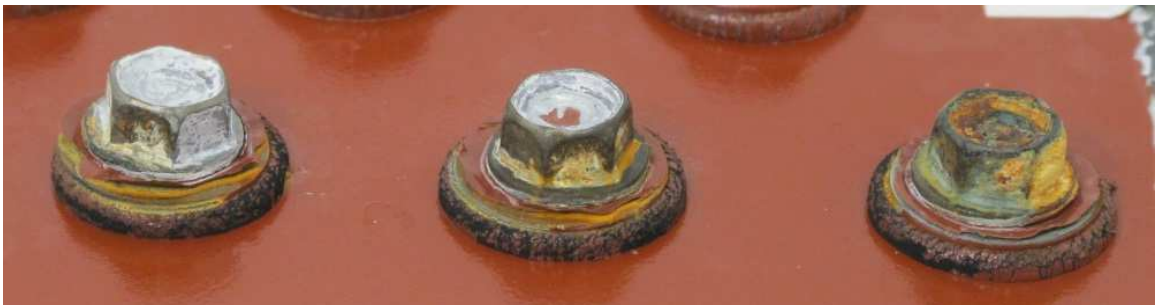
#### 4.12 Sample G, KRANIT

There was a bit of incipient rusting during the first inspection after 187 hours. In the second inspection after 425 hours, there was a small amount of rust and after 572 hours the screws were in a bad condition with lots of red rust. Test was ended after 618 hours. When the delaminated paint was removed, almost all the paint was lost.

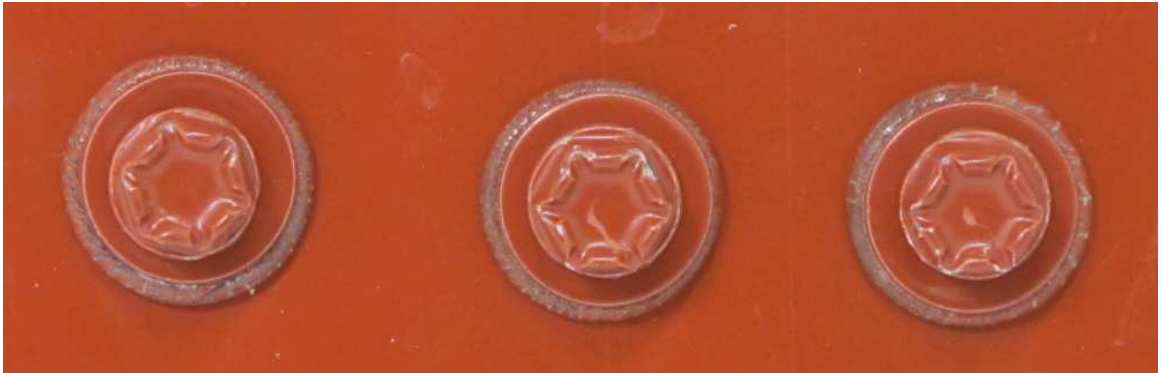
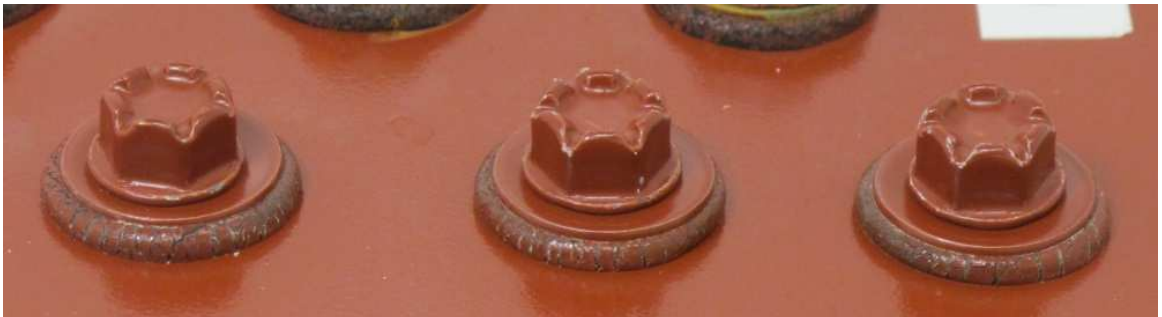
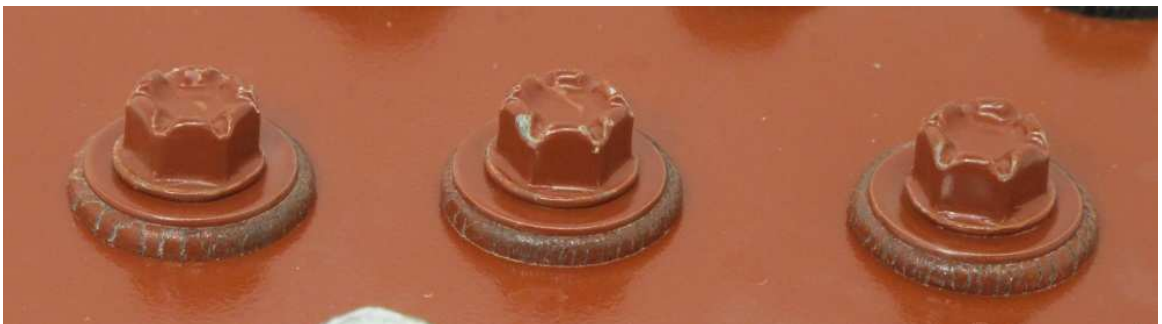
#### 4.13 Sample H, Kingi with top coat only

The screws were in a good condition during the first inspection after 187 hours. A bit of rust was found after 425 hours and small amount of rust after 572 hours. The test was ended after 618 hours because the screws were mounted on a same rack as the screws of other manufacturers, which were damaged too badly to be able to continue the test. When the delaminated paint was removed, there were some small areas in which the paint was loosened.

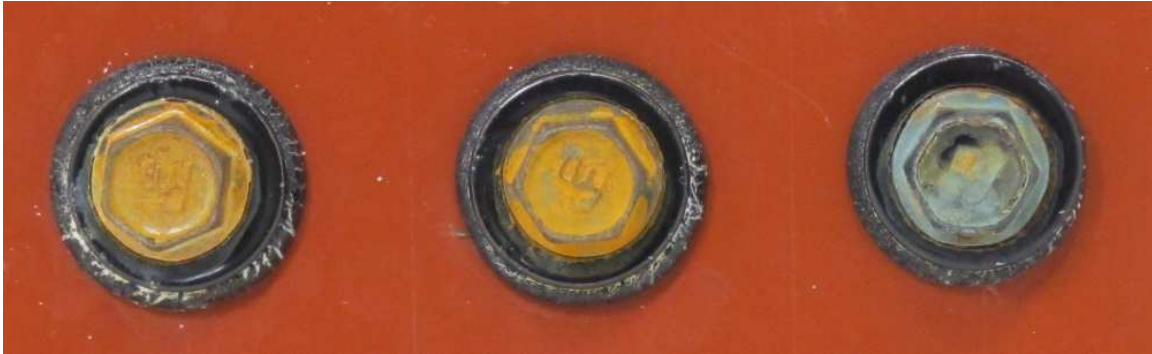
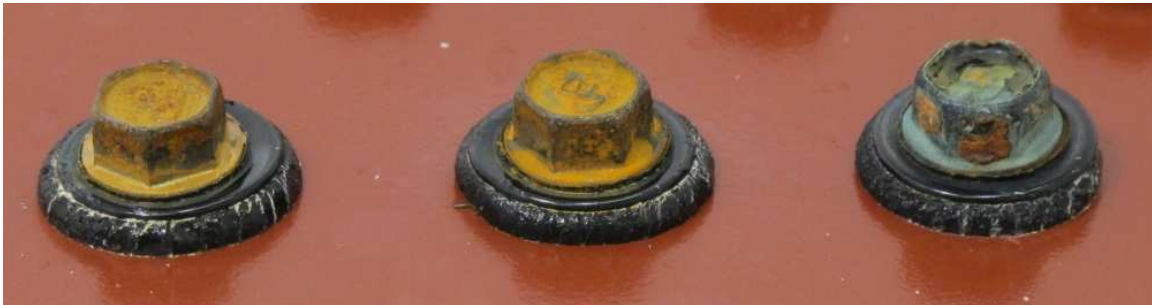
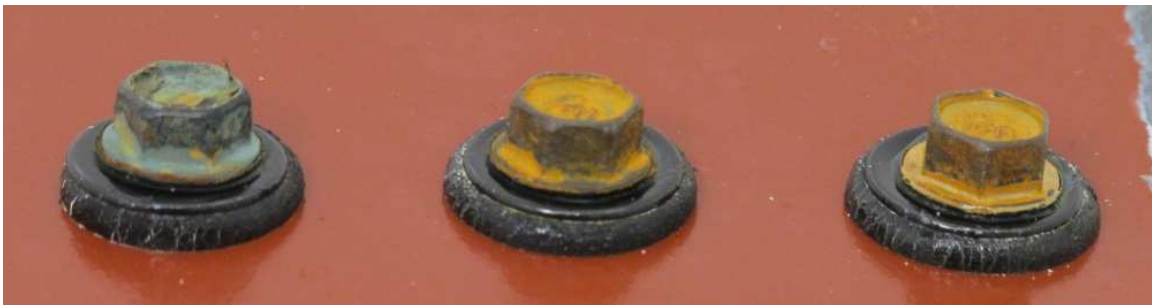
#### 4.14 Sample I, Würth 2

There was a bit of incipient rusting during the first inspection after 187 hours. In the second inspection after 425 hours, there was a lot of rust and after 572 hours the screws were in a really bad condition with lots of red rust. Test was ended after 618 hours. When the delaminated paint was removed, all the paint was lost.
