CORROSION RESISTANCE

Roofing screw test

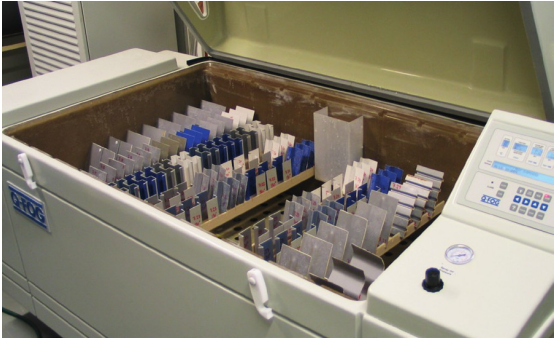
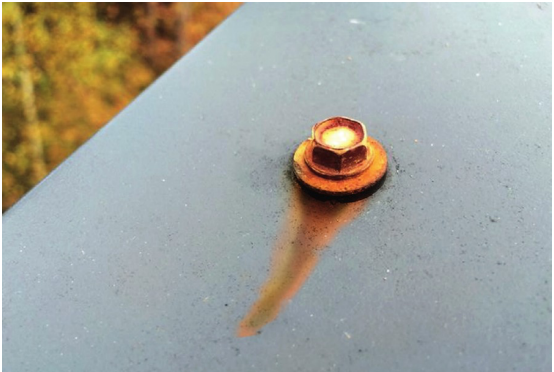
The screw samples were mounted on a sample rack at an angle of approximately 35 degrees. The tests were carried out in the corrosion chamber of the research laboratory of the HAMK Sheet Metal Centre.

Seven roofing screws from 5 different screw suppliers were examined, 1 to 3 sample screws of each. The screw samples were tested with a 360-hour salt spray test and a 1000-hour prohesion test. In the 360-hour salt spray test according to standard SFS-EN ISO 9227, the screw samples were sprayed for 360 hours with a 5 % by weight sodium chloride solution at a temperature of 35 °C. In the prohesion test according to standard ASTM G 85–94, the samples were sprayed for one hour at a temperature of 25 °C with a solution containing 0.05 % by weight sodium chloride and 0.35 % by weight ammonium sulphate. The samples were then dried for one hour in an air flow at +35 degrees. The spraying and drying phases were repeated for the 1000 hours required by the test. Intermediate inspections were carried out on the samples every 250 hours. After the test, the samples were washed and photographed. The screws were then removed from the rack and photographed again.

The KINGI® roofing screw and the roofing screws of manufacturers 3 and 4 came through the 360-hour salt spray test very well. White rust and/or red rust appeared on the other samples.

The KINGI® roofing screw also came through the 1000-hour prohesion test very well. One of the screws of manufacturer 3 (stainless) showed slight red rust, but the other screw was in good condition. Red rust and/or white rust appeared on the other screws. It should be noted that on a genuine stainless screw, red rust should, according to general understanding, be impossible in a test of this kind.

When the screws were fastened into and removed from the test base, the adhesion of the coating of the KINGI® roofing screw was found to be very good. On all the other screws, including those made of stainless steel, clear flaking of the paint could be seen by the end of the tests at the latest. Paint adhesion is of great importance for the durability of the screw head, because the paint has to withstand fastening even with a fastening tool in poor condition. If the paint on the screw does not withstand fastening, the corrosion resistance of the coating on the screw head is lost.
