| | Report No.<br>2016-20 | Tender:<br>2016-189 | Publishing date:<br>27.4.2016 | Number of<br>pages:<br>20 |
| | Customer:<br>Kingi Ltd. | | Representative of customer:<br>Jorma Kinnunen | |
| <h2>PROHESION TEST OF METAL ROOFING SCREWS</h2> | | | | |

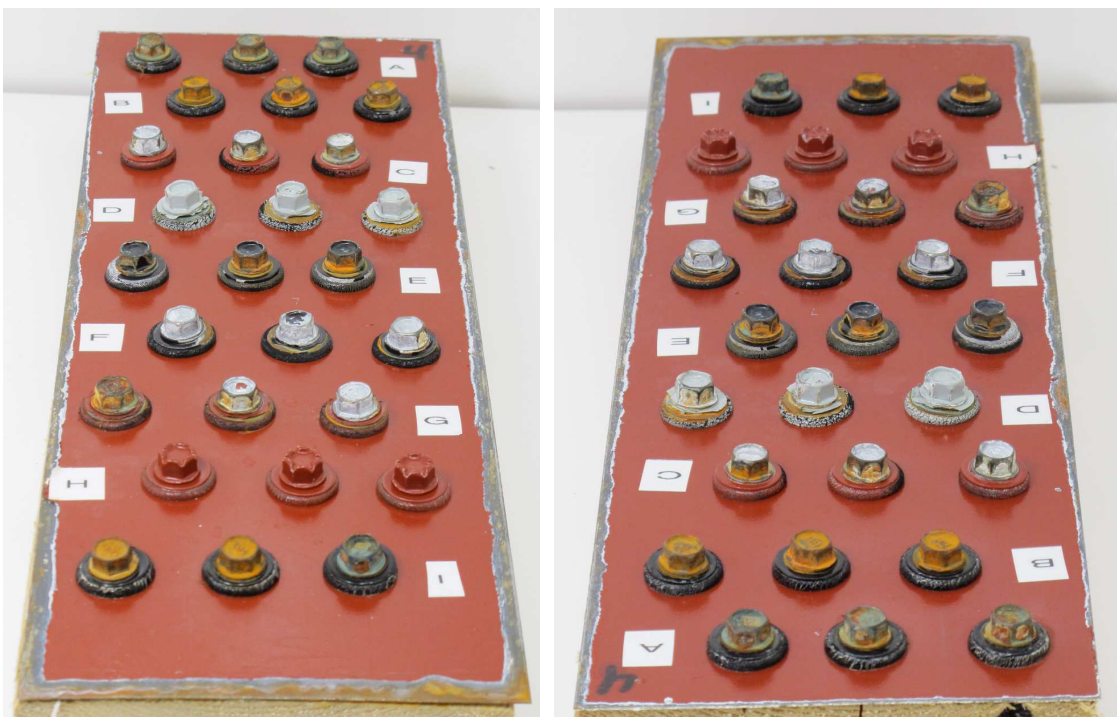
**Figure 7.** Samples were photographed from downwards (on left) and upwards (on right). The screws in these photographs are made by the other manufacturers and Kingi screw with the top coat only (H).
